The Refne landslide, Halden, Norway: case history and use of risk assessment

T. F. Smaavik
NGI, Norway, tone.fallan.smaavik@ngi.no

ABSTRACT

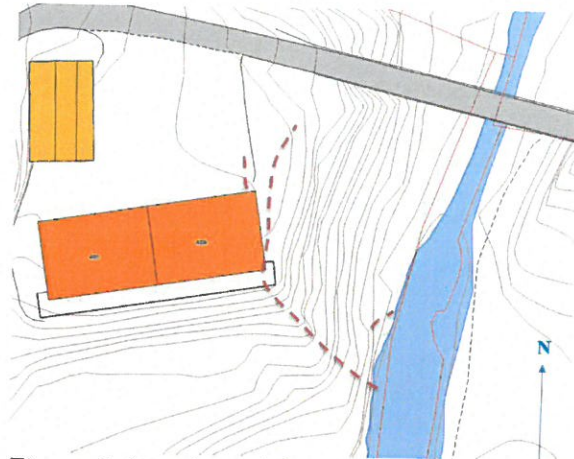
NGI was first contacted by local residents regarding cracks and displacements on top of a 16 m high, steep slope beneath the apartment block. An inspection was carried out by NGI and it was discovered that a large slope instability had developed. The slope had deformed visibly and a continuous crack had developed covering the full width of the slope beneath the apartment block. Along the crack, the slope had a vertical deformation of approx. 0,5-1 m. The southern part of the crack followed a ridge leading down to the Refne stream (Figure 2).

Figure 1 Location of the apartment block and approximate location of cracks in slope. The slope was 16 m high.

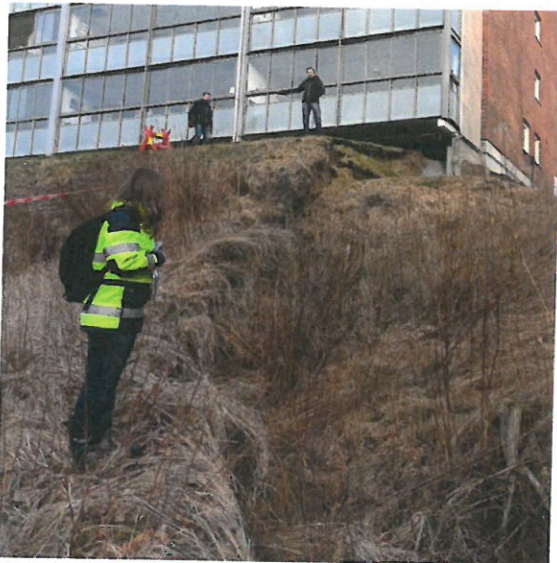
Figure 2 The backscarp of the slide. Vertical deformation 0,5-1 m.

Deformations along the side of the block were approx. 1,5-2 m. The backscarp of the slide coincided with the corner pile of the block partially exposed the corner pile foundation (Figure 3). The pile guided the crack in the way that the direction of the backscarp was forced outside the pile.

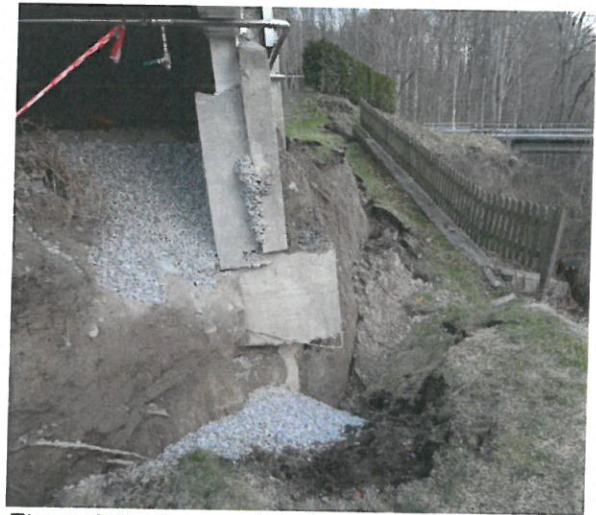
The deformations of the slope had uncovered the corner pile foundation, situated at the brink of the slope (Figures 1, 2 and 3).

Figure 3 Backscarp of the landslide restricted by the pile foundation. Concrete pile supporting the corner foundation visible.

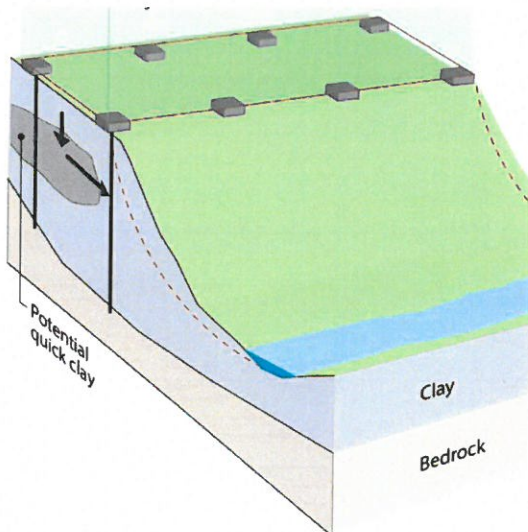
If potential quick clay under the block was to slide, all piles would likely follow the slide, break or buckle (Figure 4). Soundings performed in the first phase of the SI did not indicate quick clay underneath the building, but the scenario could not be eliminated before samples were taken and analysed. However, it was deemed unlikely that quick clay could be exposed as a result of further development of the landslide, thereby triggering a major quick clay landslide involving the building, i.e. the lowest probability class P1 was assigned.

Figure 4 Scenario A - quick clay slide

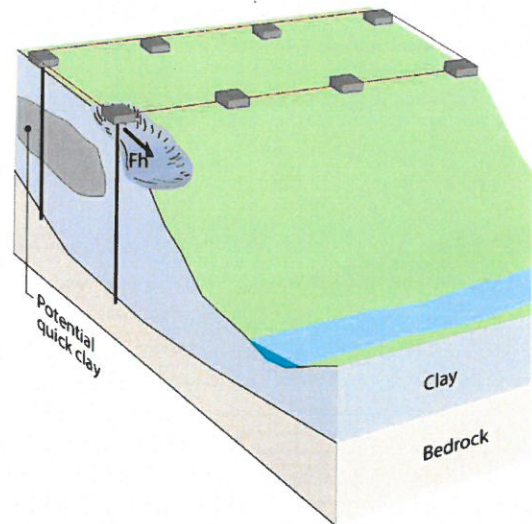
One of the concrete piles under the block was partly exposed by the landslide (Figure 3). A further development of the landslide would increasingly expose the pile, leaving it vulnerable to excessive lateral loading or horizontal displacement (Figure 5). The probability of damage to the corner pile was evaluated to be in the highest probability

class P4, i.e. damage to the pile was expected to occur within 1 year. Further movement of the landslide would certainly be expected in connection with heavy rainfall events.

Figure 5 Scenario B - Damage to corner pile

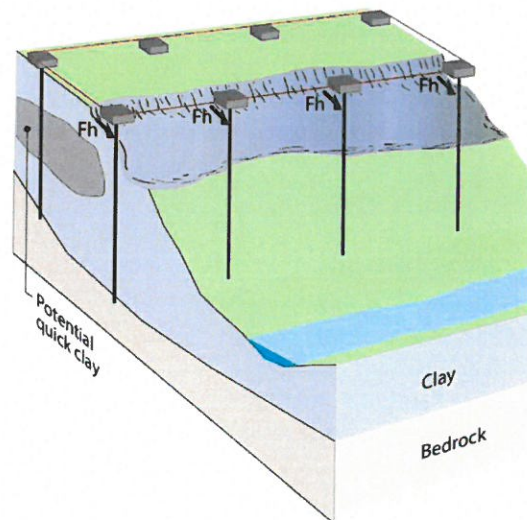
Should the landslide develop along the length of the slope, more of the piles in the pile row closest to the slope could be exposed or affected (Figure 6).

Figure 6 Scenario C - Damage to several piles in 1st row

Due to the orientation of the building not quite parallel to the slope (Figure 1), the distance from the closest piles to the slope edge increases slightly towards the north. This makes a scenario damaging several piles

slightly less probable than damage to the corner pile. For this scenario, the second highest probability class P3 was therefore assigned.

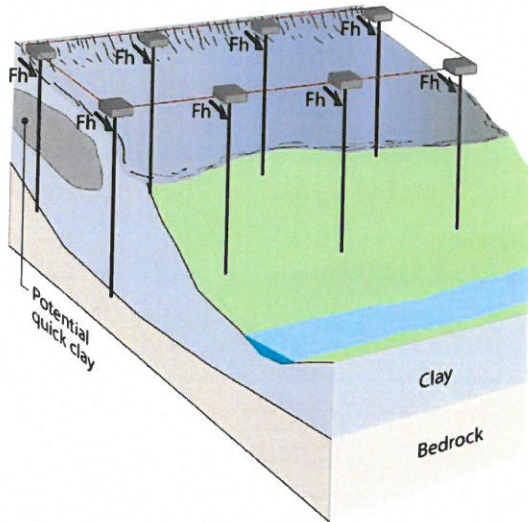
The distance between the rows of piles was approx. 6 m. Based on the SI it was considered less likely that the landslide would develop backwards to that extent and cause direct damage on the piles in the second row (Figure 7), i.e. the second lowest probability class P2 was assigned.

Figure 7 Scenario D - Damage to several piles in 2nd row

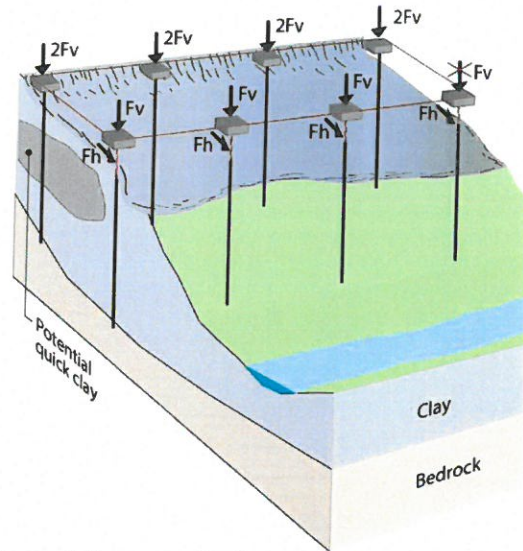
A "domino effect" may occur from redistribution of horizontal and vertical loads. It is a relevant scenario if failure of one or several piles leads to deformations that cause additional load on, and potential failure of, the next row of piles (Figure 8). The second highest probability class P3 was assigned for this scenario.

Figure 8 Scenario E - Domino effect - failure of all piles
