Sjøledning Sandvika

Borplan	Prosjektnr. -	Kartnr. 010
Utførte boringer	Utført CSO	Dato 2019-11-12
	Kontrollert MaR	Godkjent CSO

Bærum kommune - sjøledning Sandvika

Rapport nr.
20140865-11

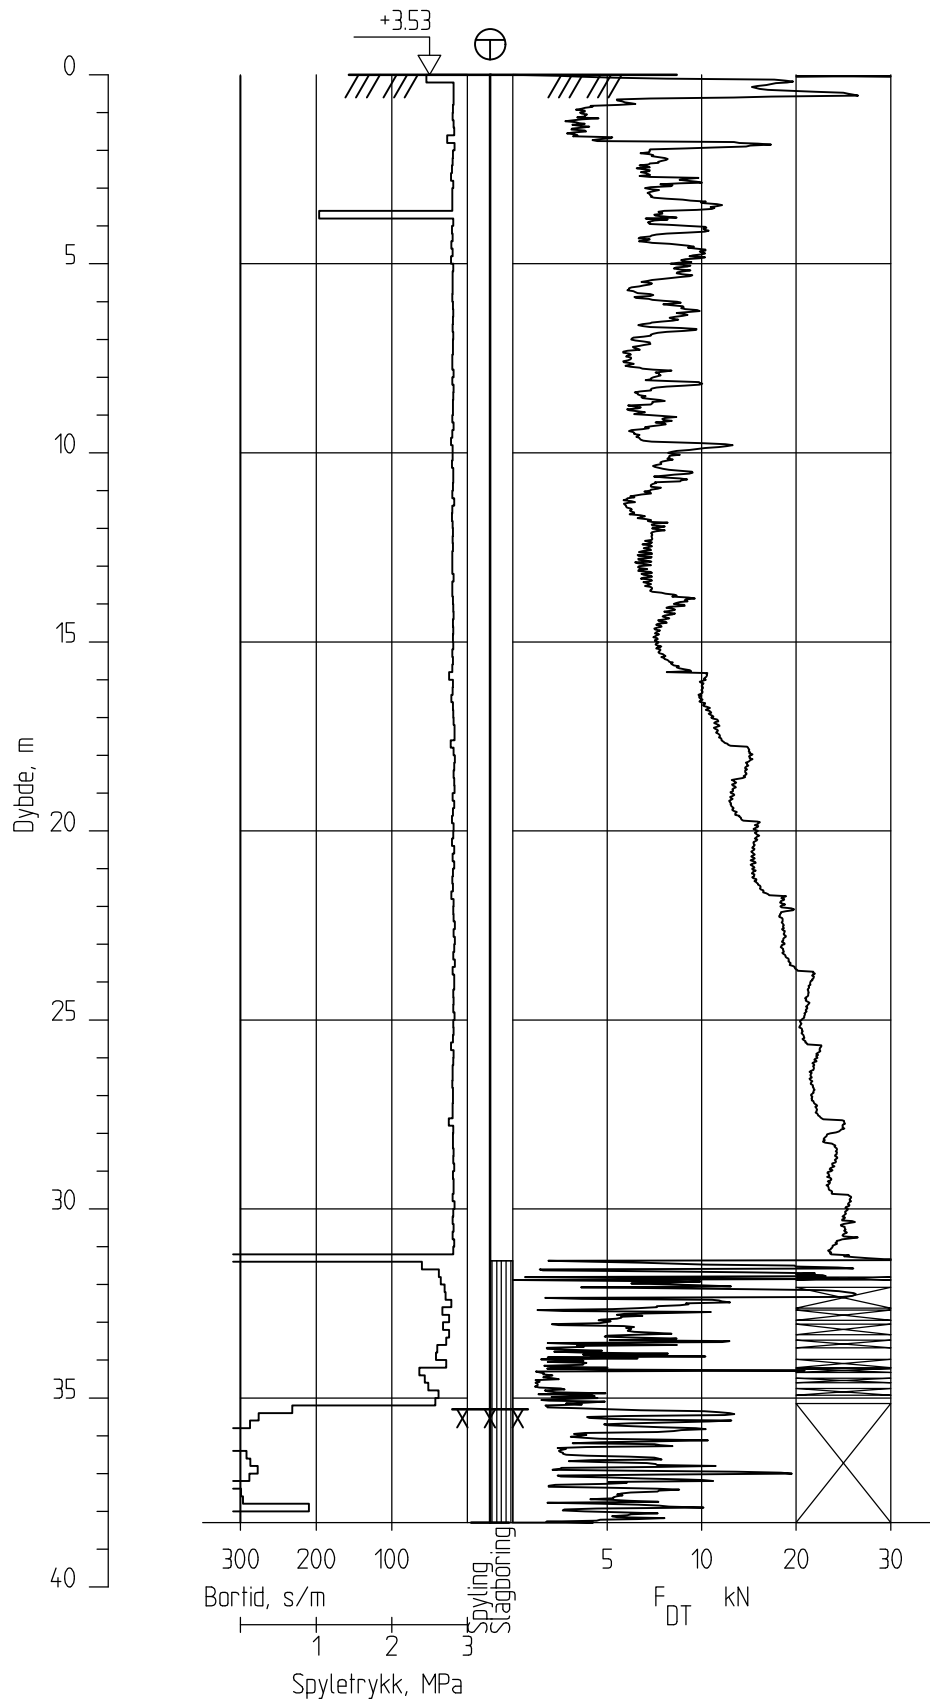
Totalsondering
M = 1 : 200

Borhull MU_1S
Posisjon: X 1210513.17 Y 101321.47

Dato boret :05.09.2005

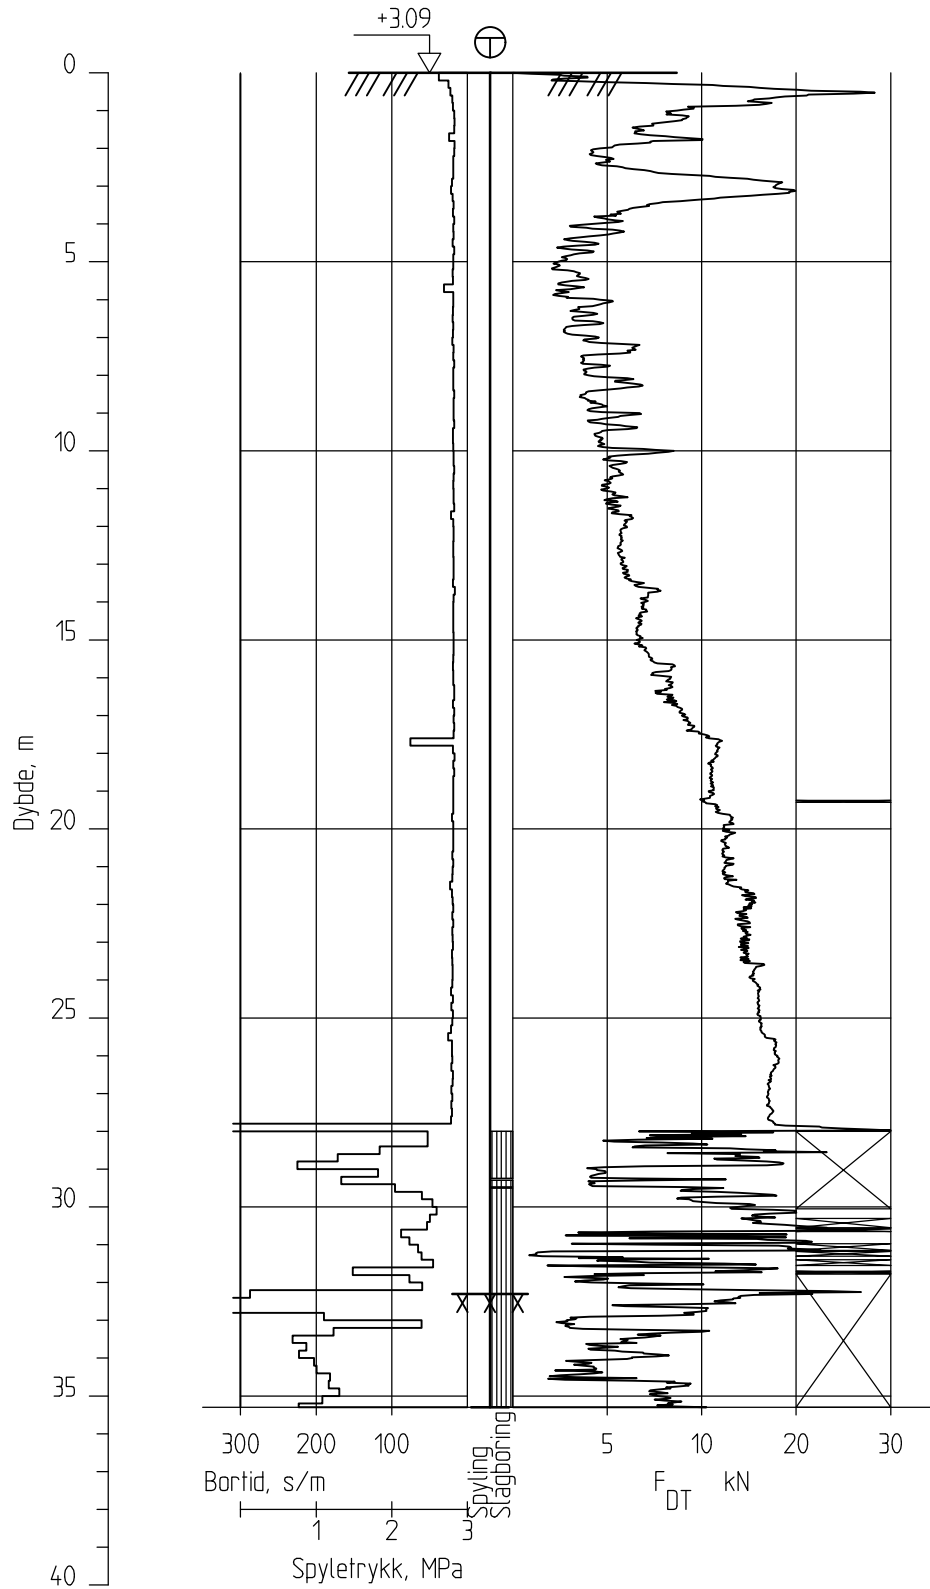
Totalsondering
M = 1 : 200

Borhull MU_2S
Posisjon: X 1210525.21 Y 101334.43

Dato boret :31.08.2005

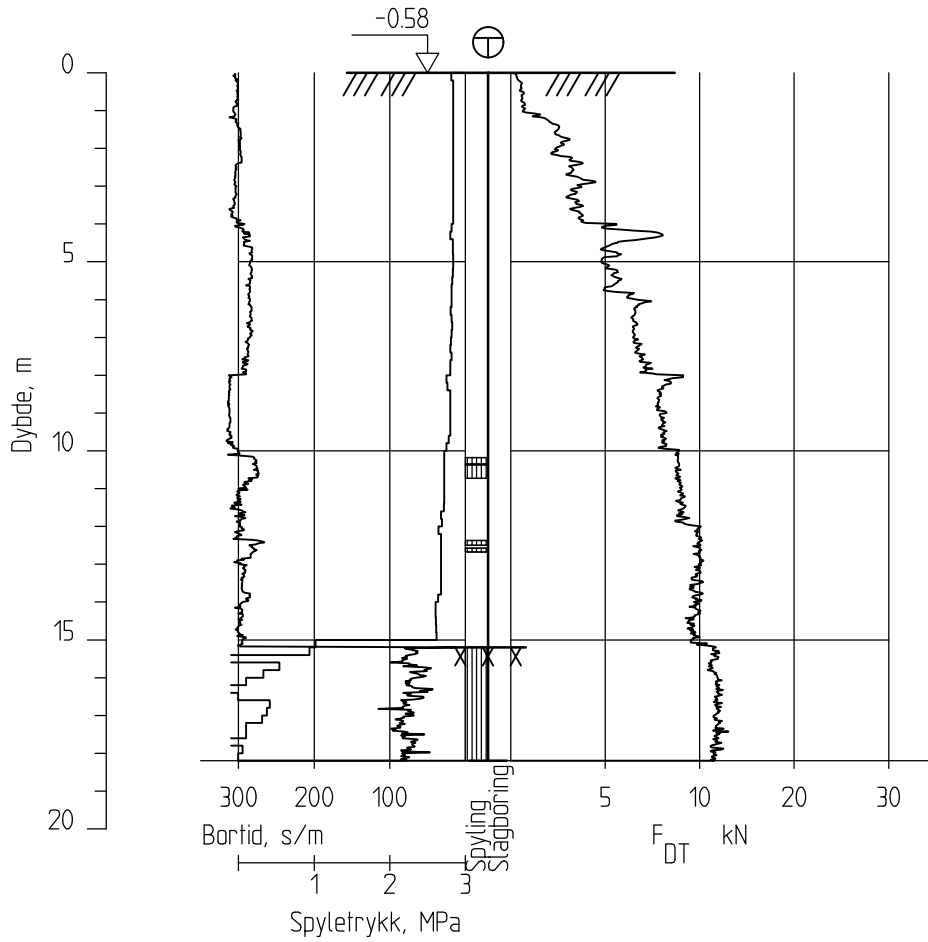
Totalsondering
M = 1 : 200

Borhull MU_3S

Posisjon: X 1210537.26 Y 101348.39

Dato boret :07.09.2005

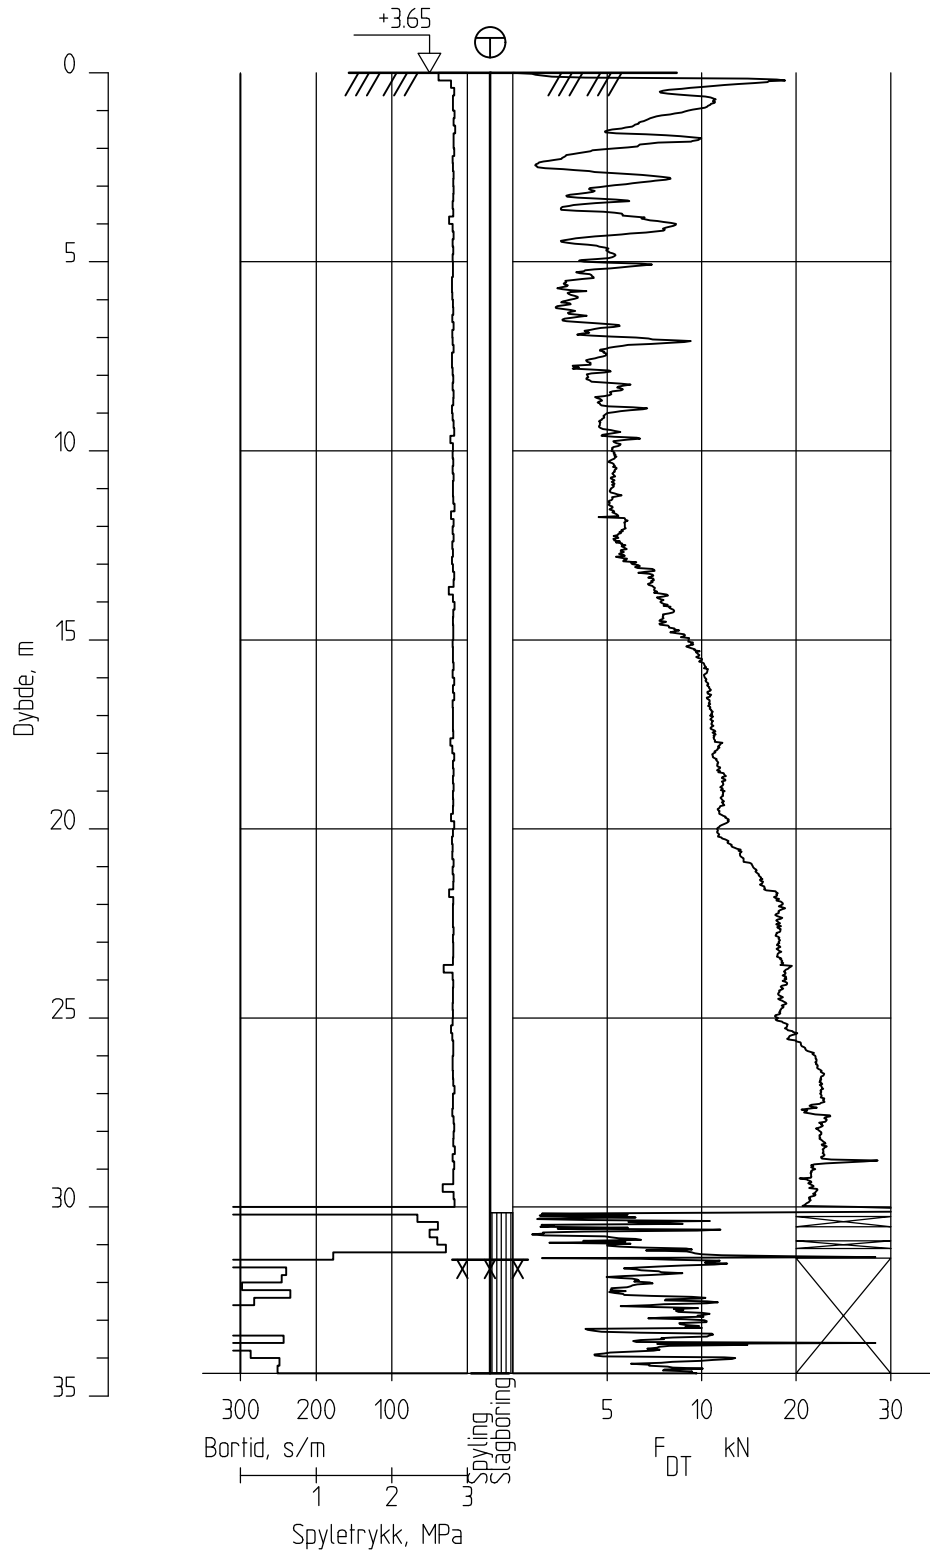
Totalsondering
M = 1 : 200

Borhull MU_6S

Posisjon: X 1210529.12 Y 101307.42

Dato boret :01.09.2005

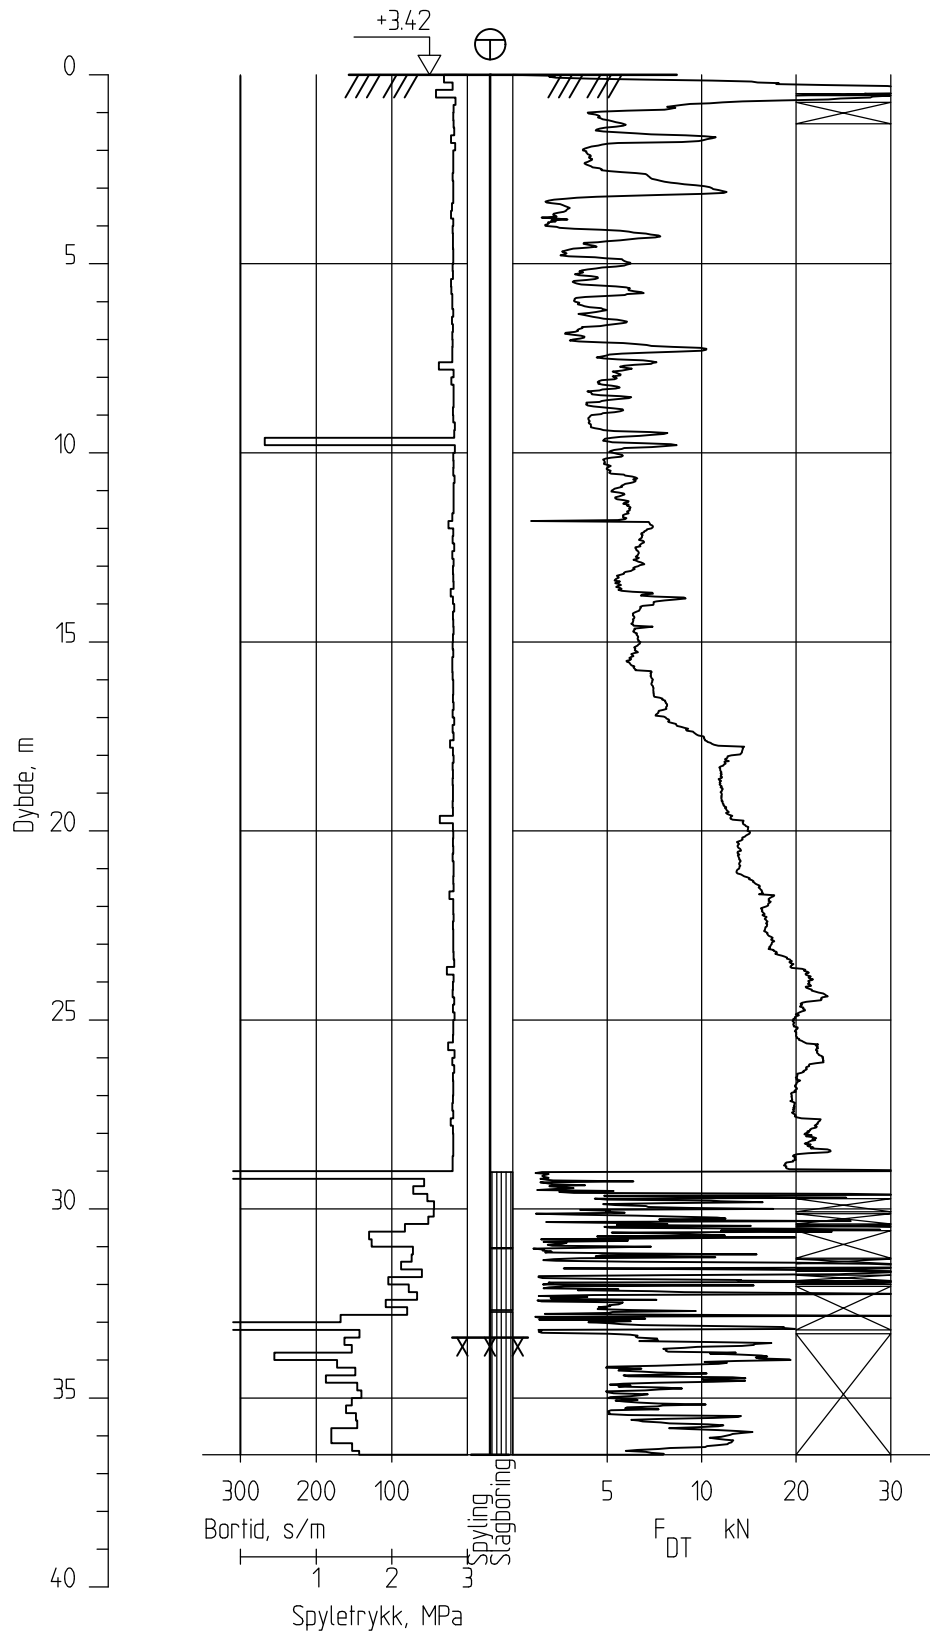
Totalsondering
M = 1 : 200

Borhull MU_7S
Posisjon: X 121054.116 Y 101320.38

Dato boret :31.08.2005

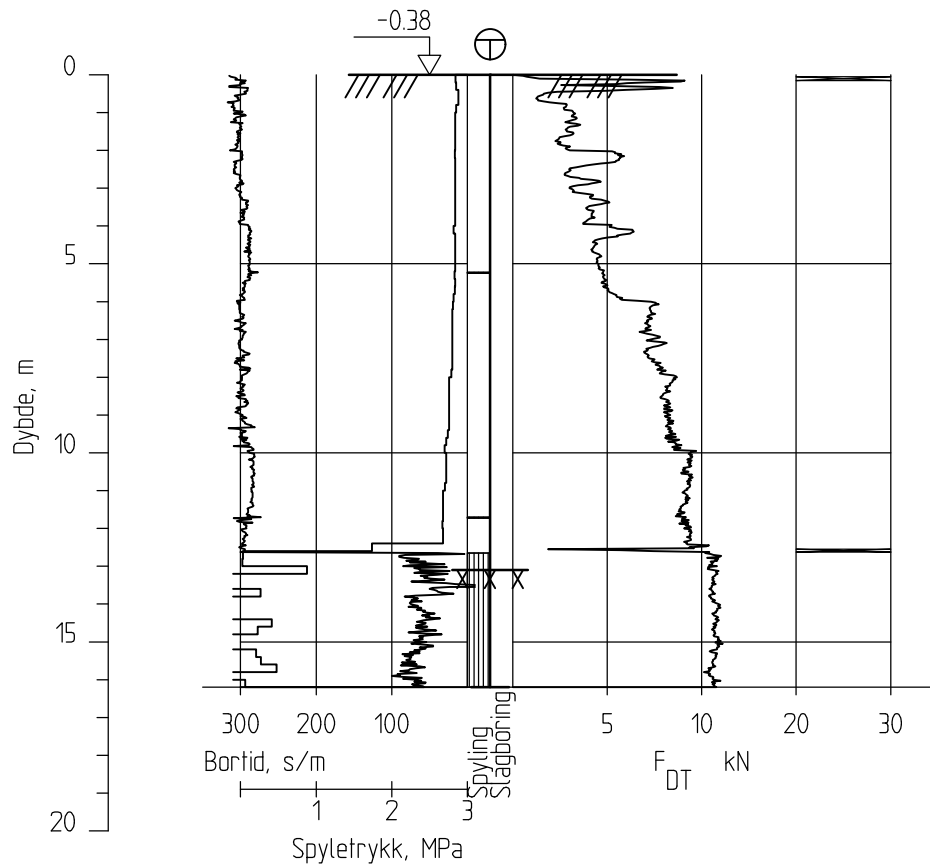
Totalsondering
M = 1 : 200

Borhull MU_8S

Posisjon: X 1210553.21 Y 101334.34

Dato boret :07.09.2005

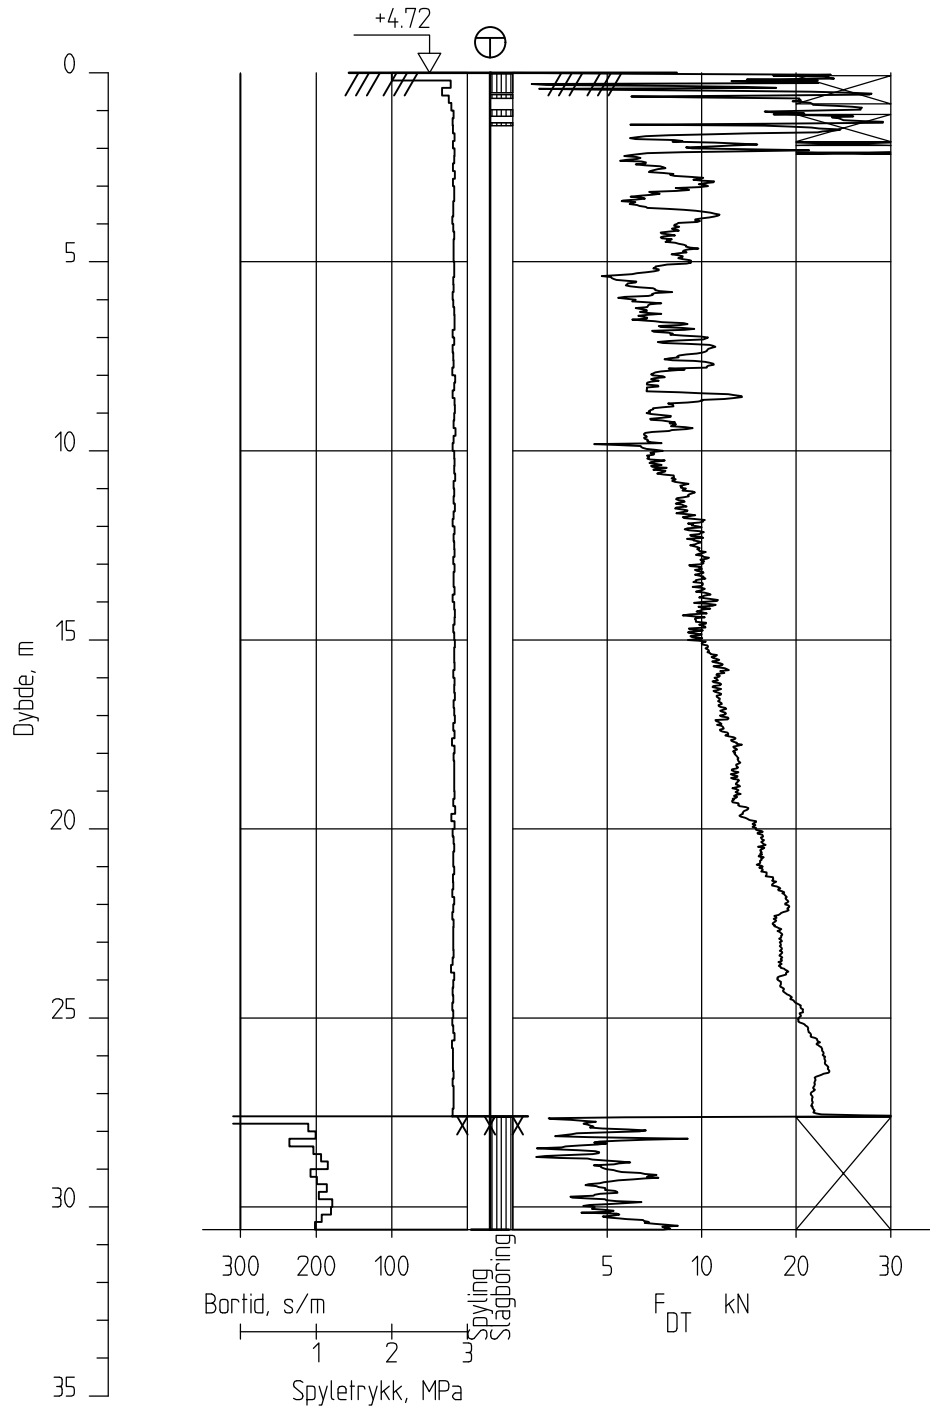
Totalsondering
M = 1 : 200

Borhull MU_11S

Posisjon: X 1210545.08 Y 101294.37

Dato boret :01.09.2005

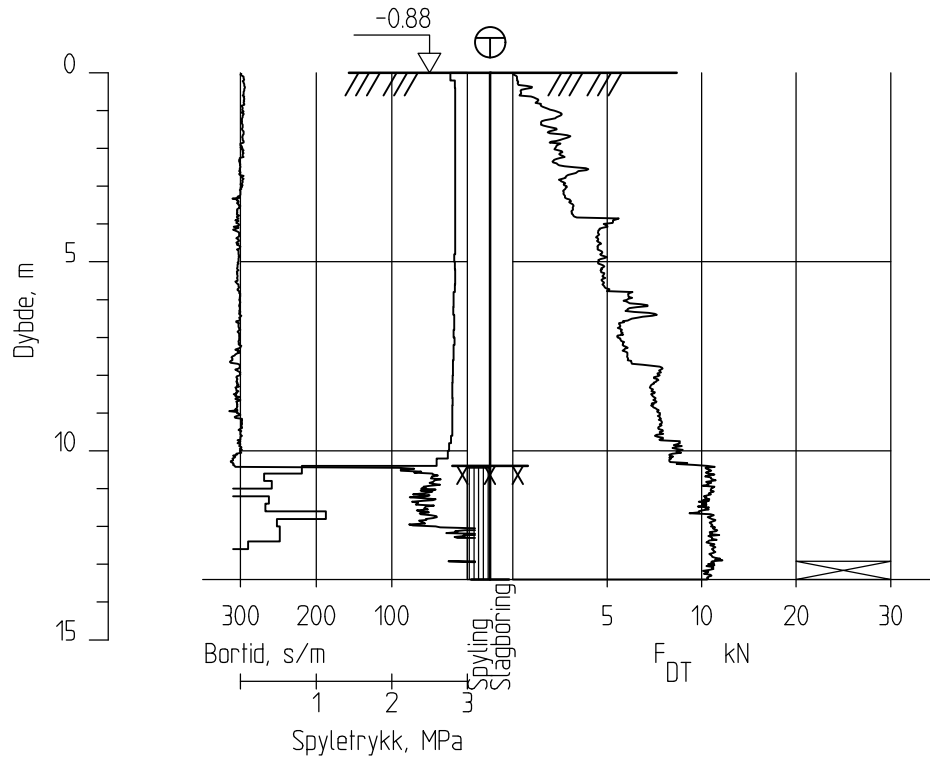
Totalsondering
M = 1 : 200

Borhull MU_13S

Posisjon: X 1210569.17 Y 101322.29

Dato boret :07.09.2005

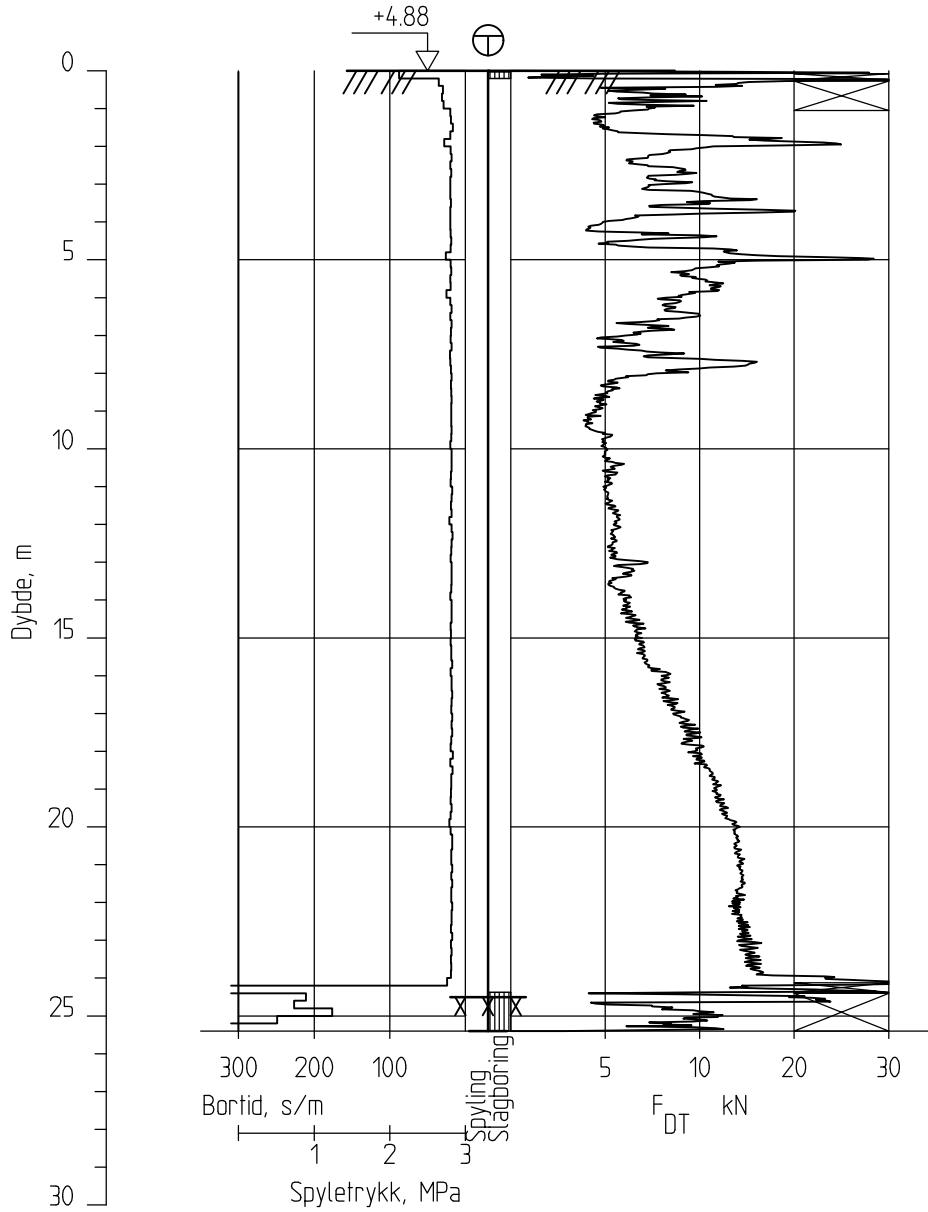
Totalsondering
M = 1 : 200

Borhull MU_16S

Posisjon: X 1210569.04 Y 101283.29

Dato boret :01.09.2005

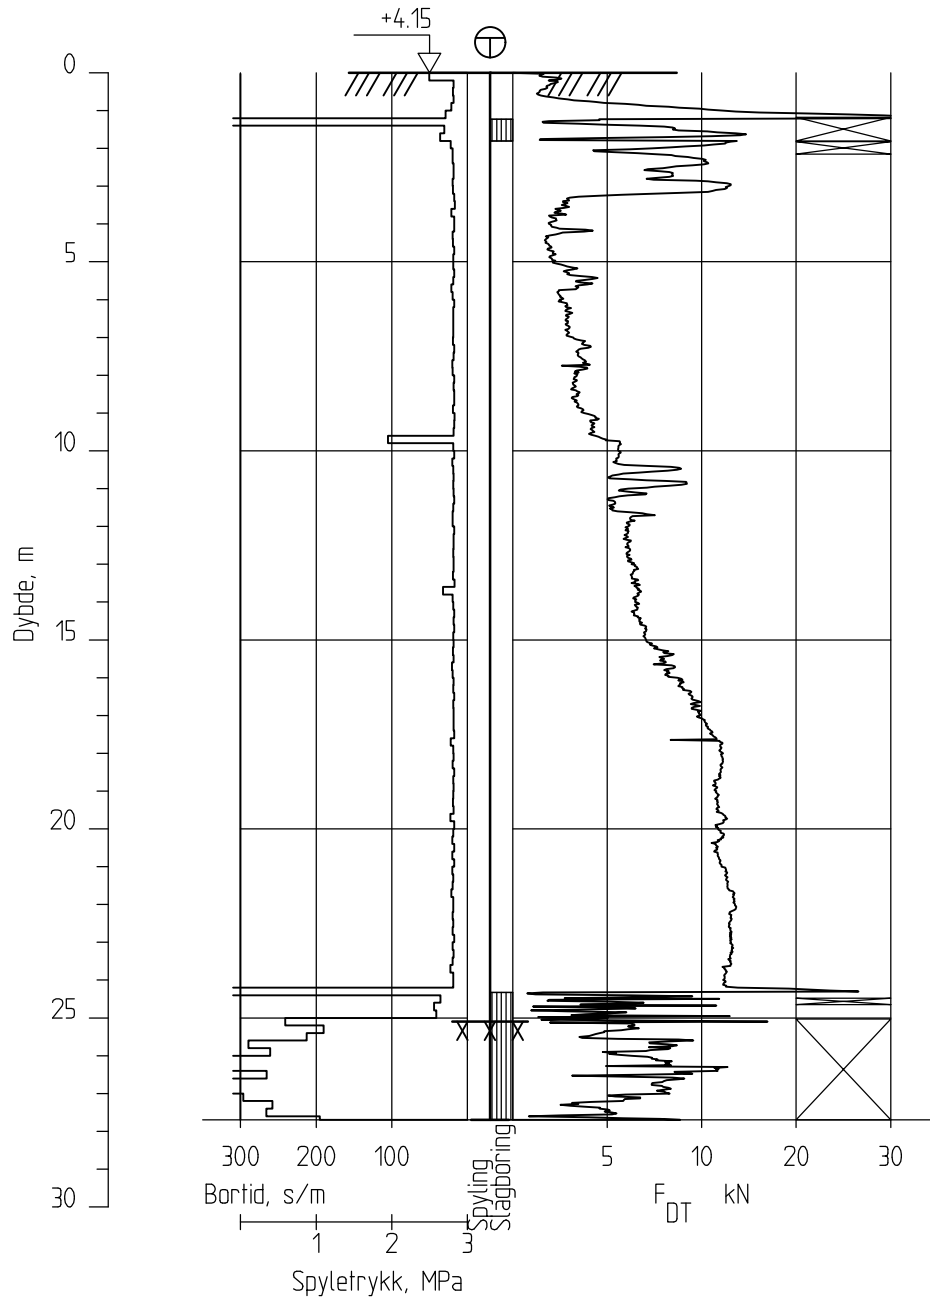
Totalsondering
M = 1 : 200

Borhull MU_20S

Posisjon: X 1210609.01 Y 101274.15

Dato boret :05.09.2005

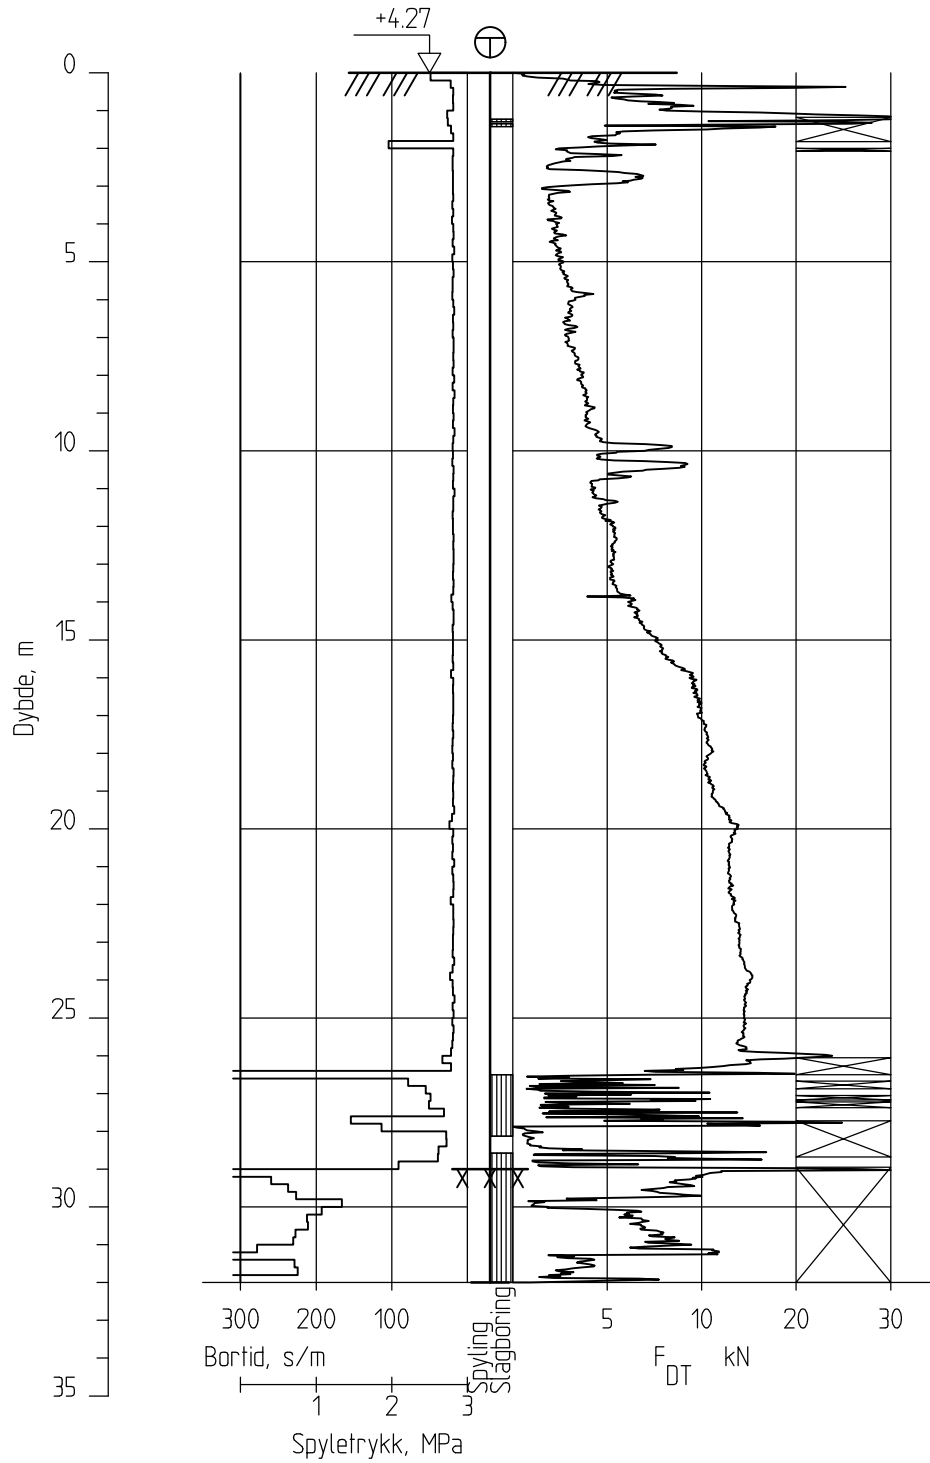
Totalsondering
M = 1 : 200

Borhull MU_24S
Posisjon: X 1210620.97 Y 101261.11

Dato boret :05.09.2005

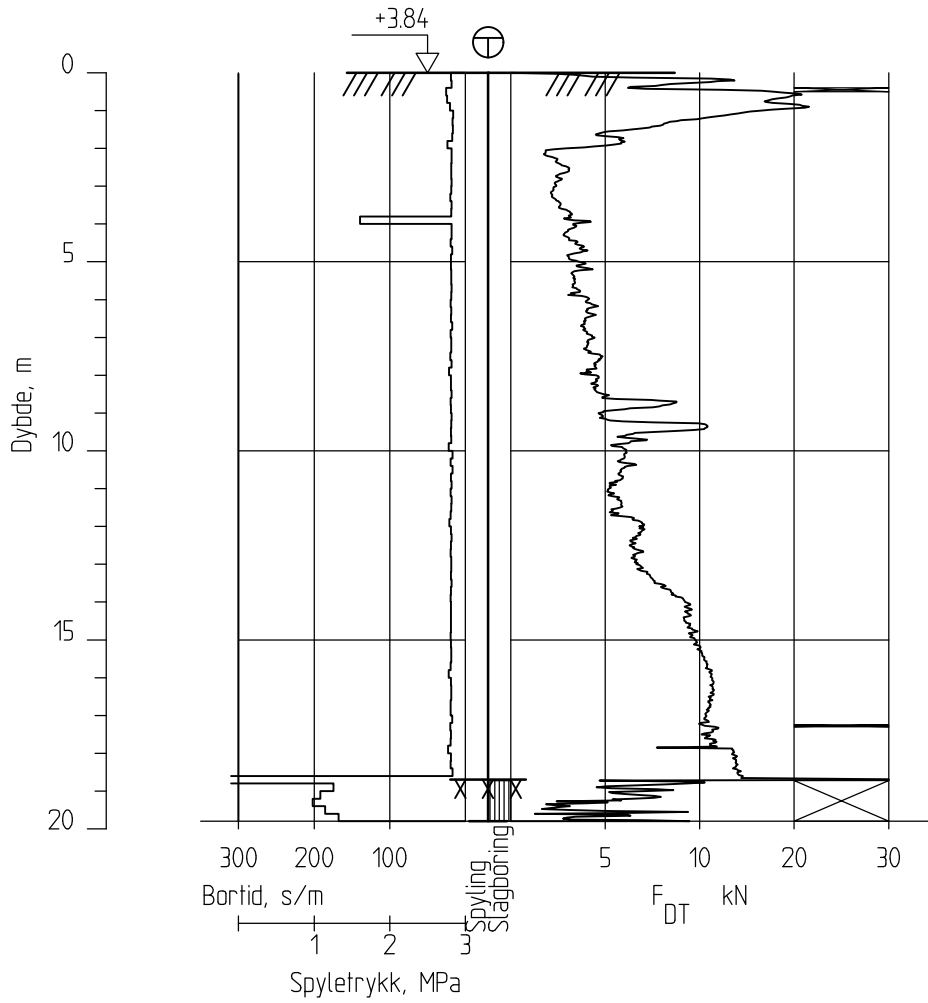
Totalsondering
M = 1 : 200

Borhull MU_28S

Posisjon: X 1210636.92 Y 101247.06

Dato boret :05.09.2005
